Re: Work Plan for Rock Placement on the Time Critical Removal Action
Armored Cap, San Jacinto River Waste Pits Superfund Site, Channelview, Texas

Table 1
Armored Cap Maintenance Locations
March 2016

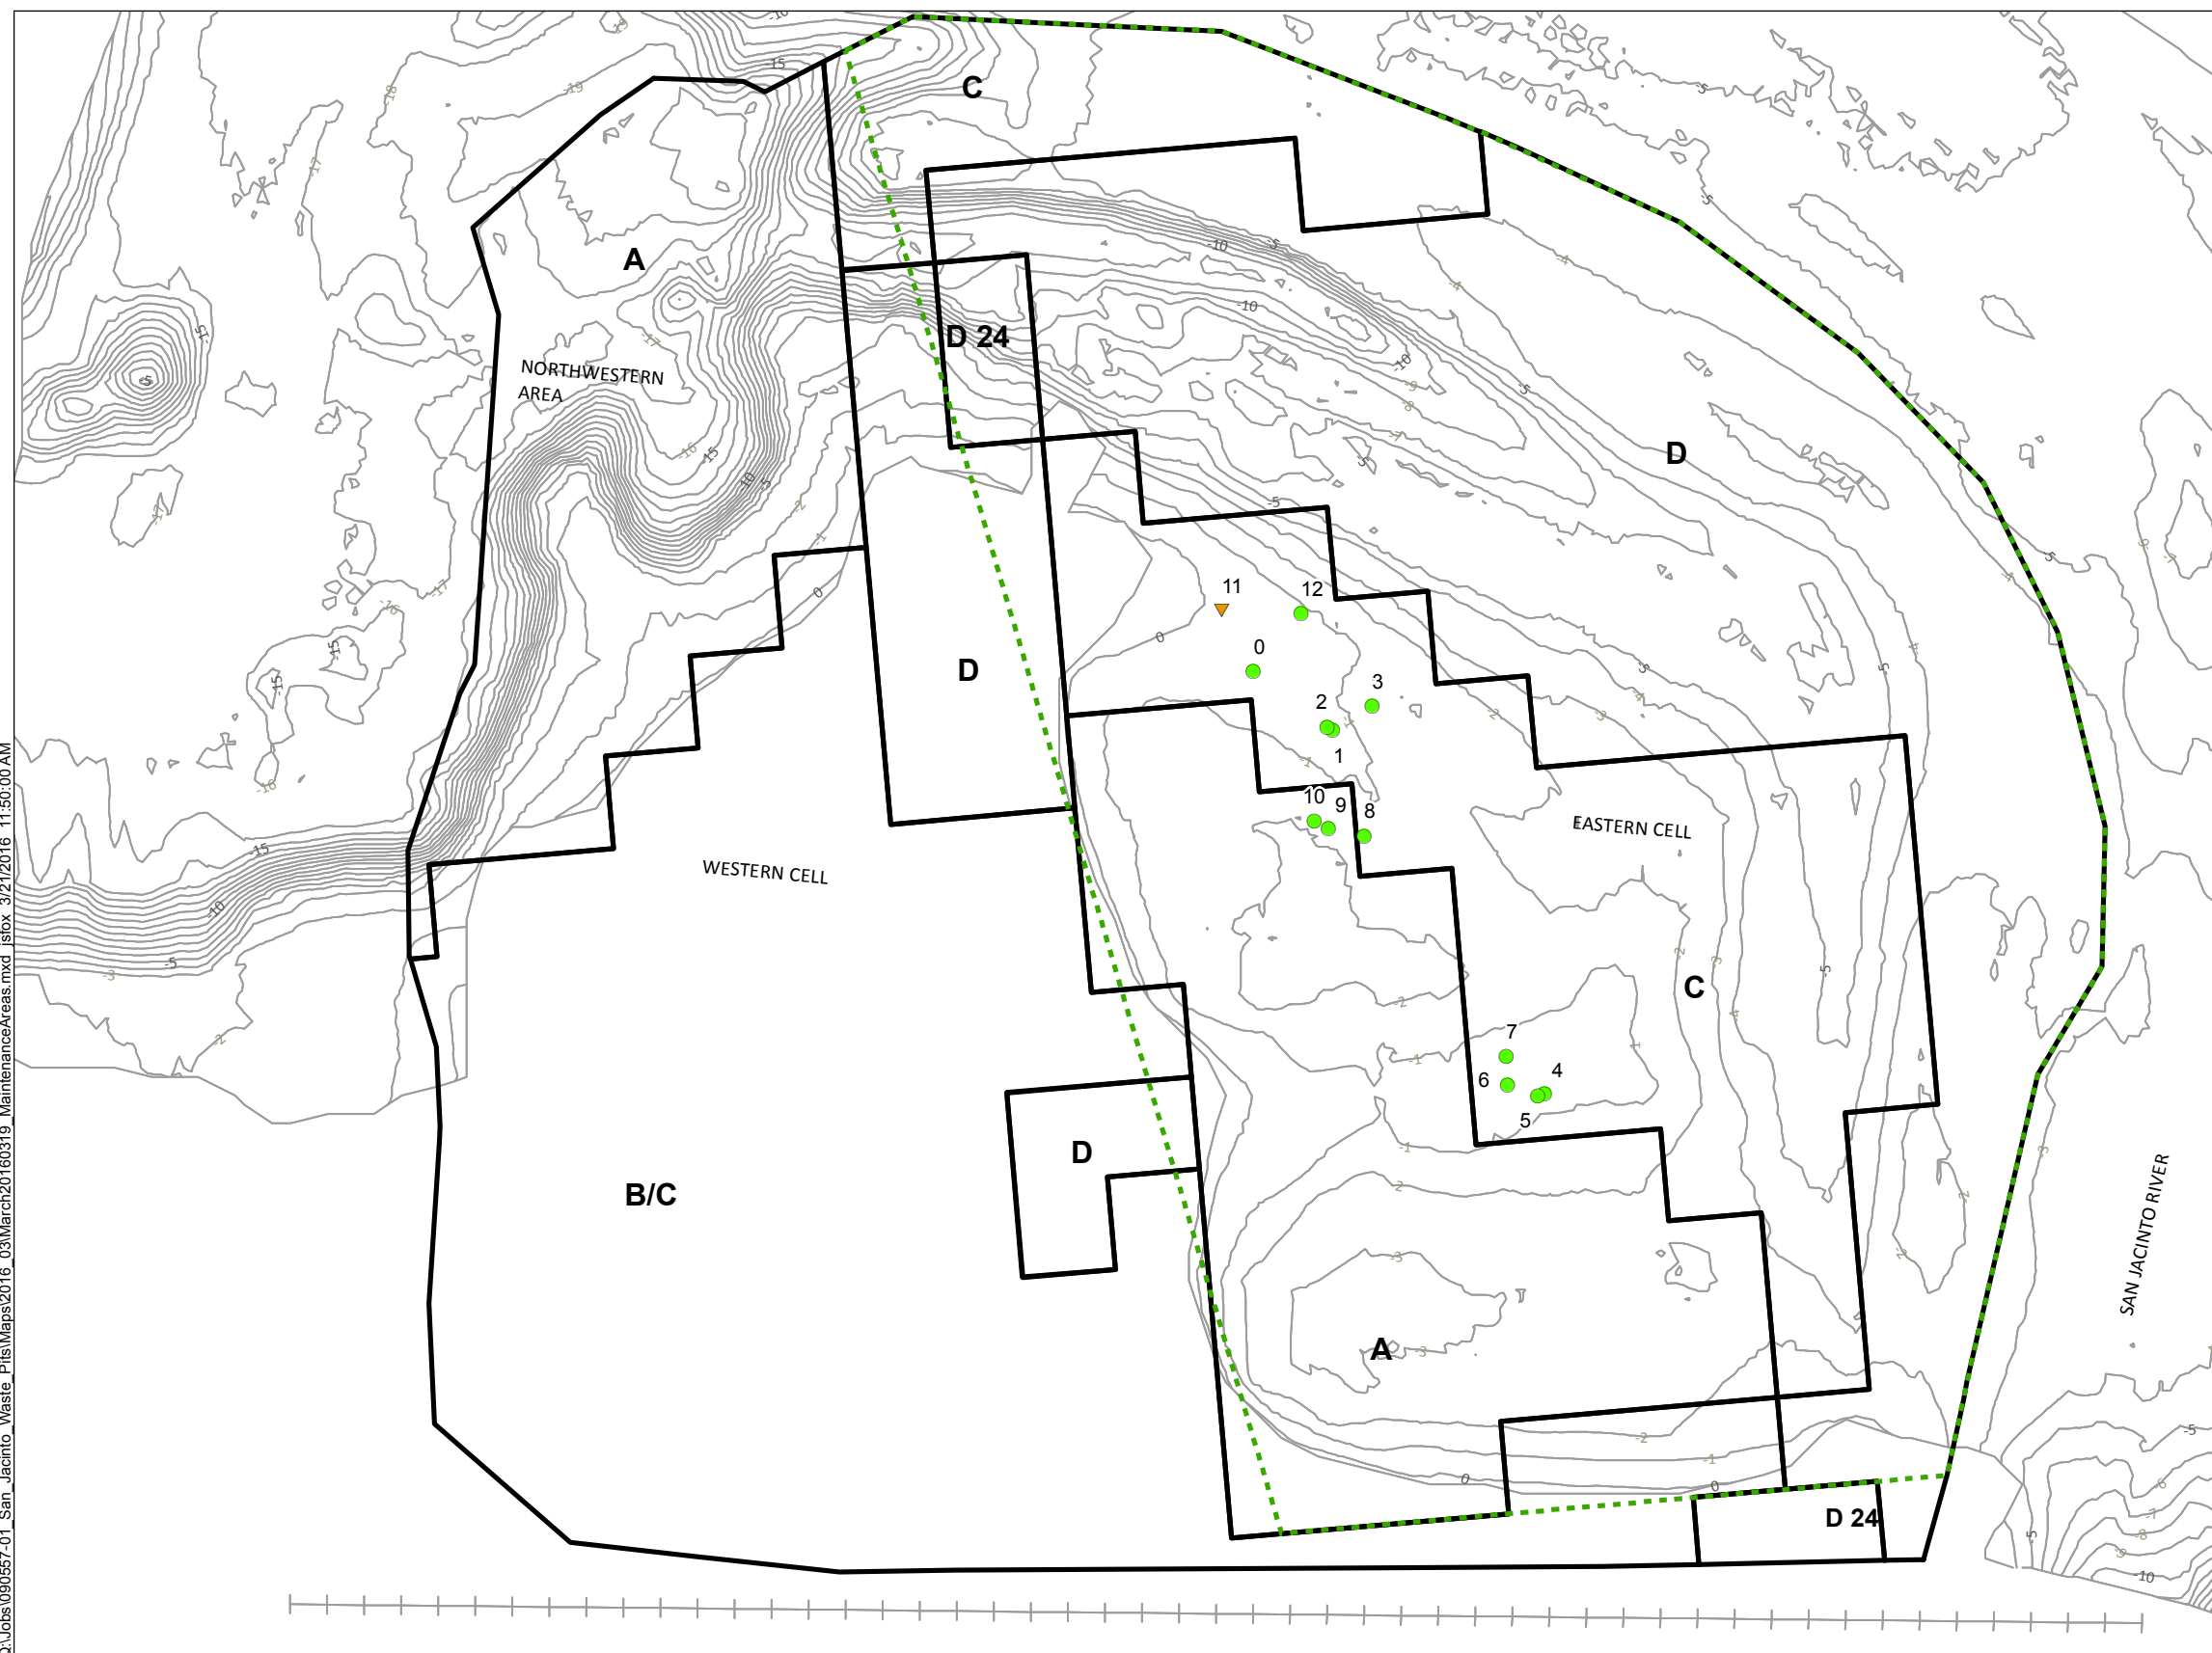
The results of the probing and visual inspection identified several discrete areas (e.g. 1' x 1') where geotextile was exposed, as summarized in Table 1 and shown on the attached Figure 1.

As you are aware, a skid steer front-end loader became disabled on the armored cap and the Respondents will place additional geotextile and armor rock in this area. In addition, the geotextile edge identified at Location 11 will also be addressed by placement of geotextile and armor rock.

Maintenance Location	Comment	X (UTM NAD83 - 15N)	Y (UTM NAD83 - 15N)	Maintenance Plan
0	Exposed Geotextile with rock beneath. Indicative of Lap Joint.	300665.5156	3297847.47	Add rock
1	Exposed Geotextile is 2x2 feet. Some rock aggregate present. Thin cap rock region is 2x6 feet.	300672.5976	3297832.841	Add rock
2	Exposed geotextile 2x2 feet in area. Some rock aggregate present.	300672.013	3297833.713	Add rock
3	Exposed Geotextile 2x3 feet in area. Some rock aggregate present.	300680.1521	3297833.27	Add rock
4	Exposed Geotextile is 1x3 feet in area. Some rock aggregate present.	300675.29	3297763.589	Add rock
5	Exposed Geotextile is 1x1 feet in area. Some rock aggregate present.	300674.1382	3297763.769	Add rock
6	Exposed Geotextile is 1x1 feet in area. Some rock aggregate present.	300670.6068	3297767.763	Add rock
7	Exposed Geotextile is 1x1 feet in area. Some rock aggregate present.	300672.5902	3297771.977	Add rock

8	Exposed Geotextile is 2x1 feet in area. Some rock aggregate present.	300668.9628	3297815.019	Add rock
9	Exposed Geotextile is 1x1 feet in area. Some rock aggregate present.	300664.2992	3297818.844	Add rock
10	Exposed Geotextile is 2x2 feet in area. Some rock aggregate present.	300662.8045	3297821.023	Add rock
11	Exposed Geotextile, cause unknown. Some rock aggregate present. Possible joint.	300665.6821	3297858.861	Add rock and geotextile
12	Centroid for area of exposed geotextile and thin cap rock. Some rock aggregate present. 20 square feet of area total.	300676.9607	3297852.277	Add rock

Armor rock will be placed over each maintenance location shown on Figure 1 to assure that the design thickness of armor rock is present at all locations. As part of the Time Critical Removal Action planning for cap maintenance, two stockpiles of armor rock (armor rock C and armor rock D) were purchased and staged near the Site, and armor rock C will be used for this maintenance activity. Armor rock C is larger than or equivalent to the size of the
